VESCOM AMERICA FIRE TEST REPORT

NFPA 286 TESTING ON 20 OZ. TYPE II PVC WALLCOVERING WITH OSNABURG (POLYESTER/COTTON) BACKING WHEN INSTALLED TO AN INTERIOR WALL

G102951522SAT-010

Series/Model: VA-WC-20-OS-17

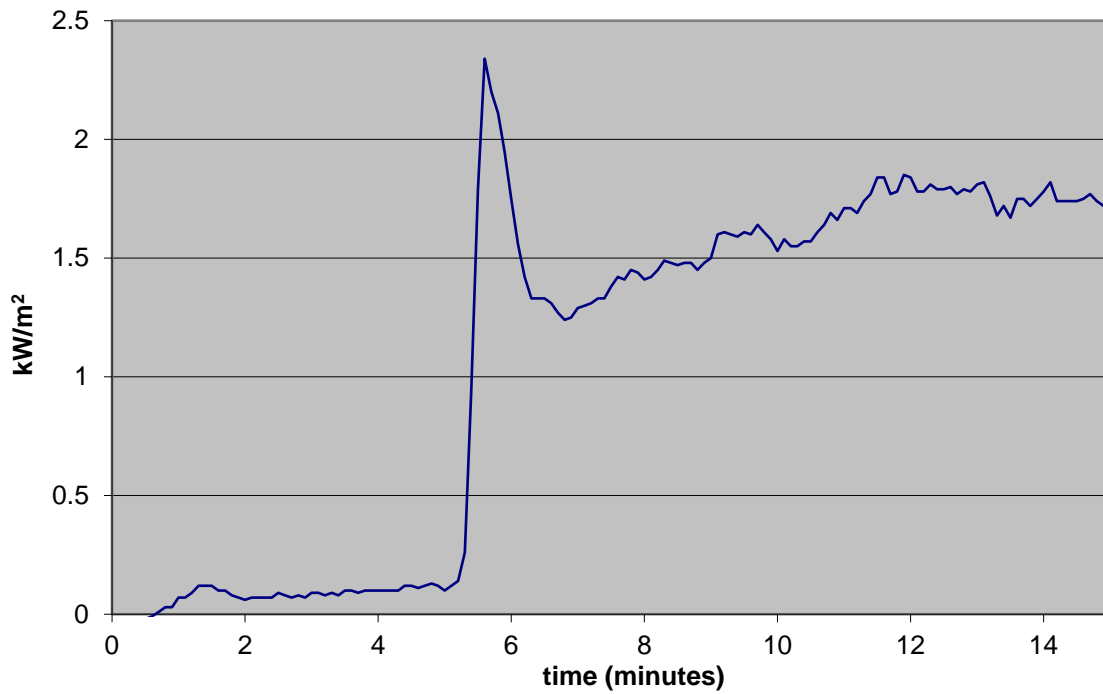
Graph No. 4

Radiant Heat
