VESCOM AMERICA FIRE TEST REPORT

NFPA 286 TESTING ON 20 OZ. TYPE II PVC WALLCOVERING WITH OSNABURG (POLYESTER/COTTON) BACKING WHEN INSTALLED TO AN INTERIOR WALL

G102951522SAT-010

TEST REPORT FOR VESCOM AMERICA

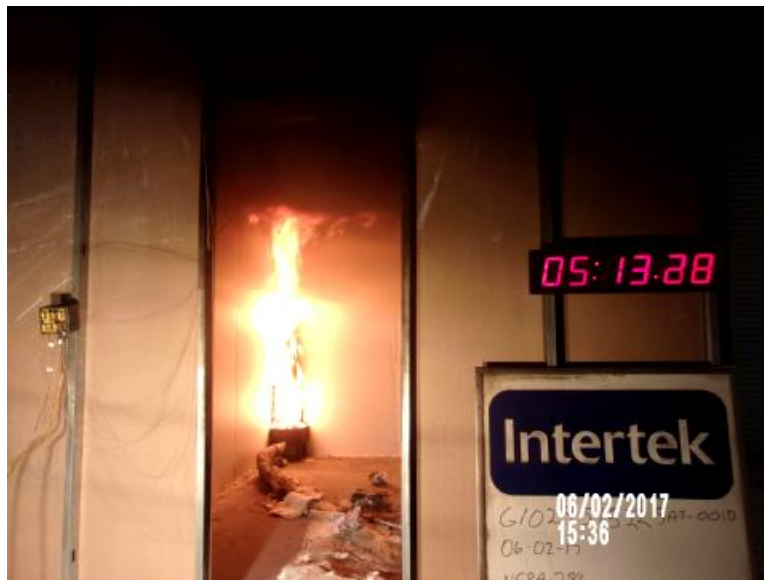
Photo No. 4
Gas flow 160kW

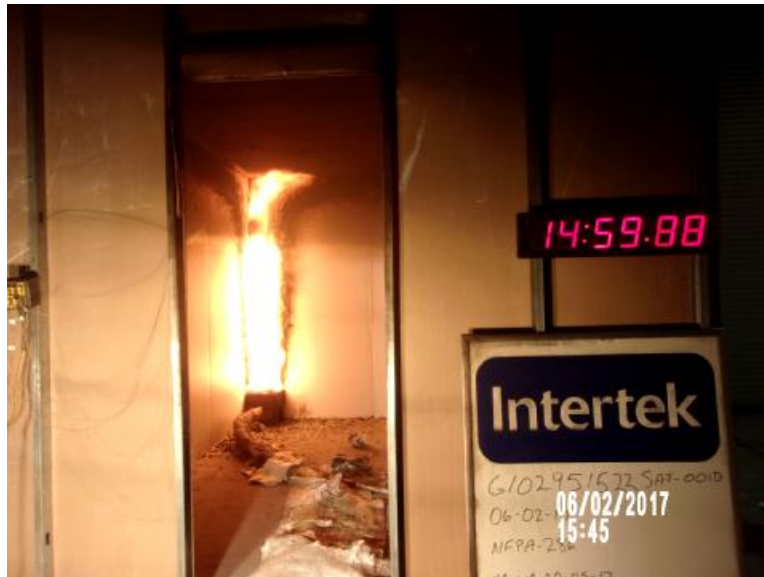
Photo No. 5
End of test

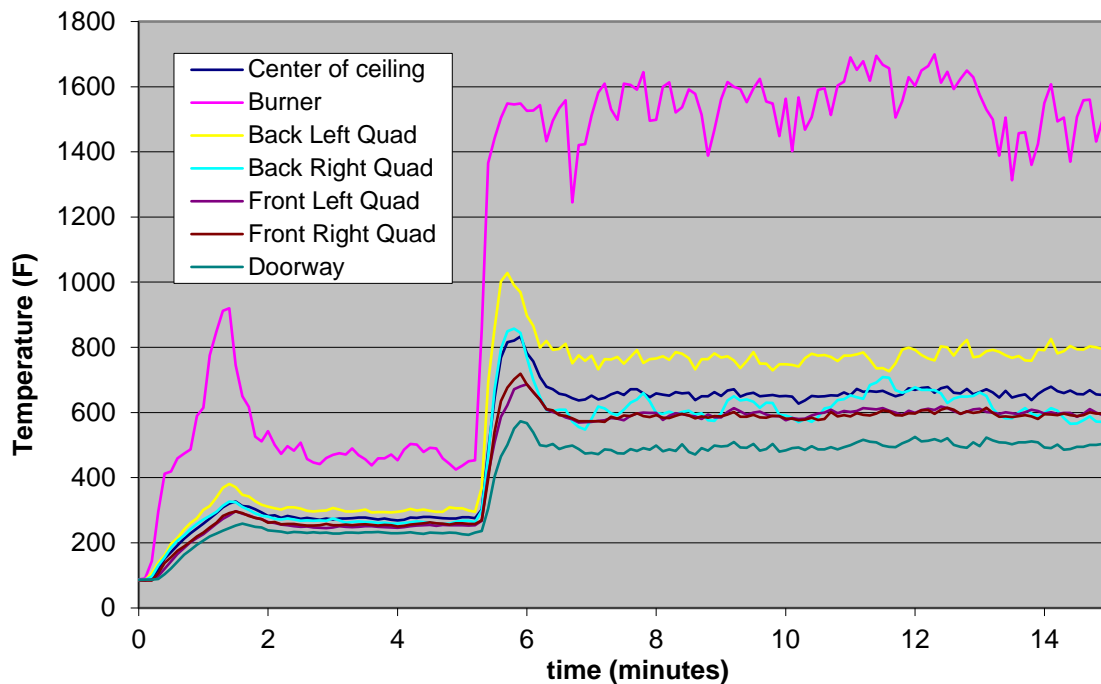
Graph No. 1
Thermocouple Data

2015 IBC SECTION 803.1.2.1 & NFPA 286 ANNEX C PERFORMANCE CRITERIA	TEST OBSERVATIONS	PASS/FAIL
During 40 kW exposure, flames should not spread to the ceiling.	Flames did not spread to the ceiling during the 40kW exposure.	PASS
During the 160 kW exposure, the interior finish should not spread to the outer extremity of the sample on any wall or ceiling	Flames propagation to the outer extremities did not occurred during the 160kW exposure.	PASS
<p>During the 160 kW exposure, the interior finish should not flashover as defined by NFPA 286.</p> <ul style="list-style-type: none"> •Peak Heat Release > 1 MW •Floor Heat Flux > 20 kW/m² •Average Upper Layer Temperature > 1,112°F •Flames exiting doorway •Auto ignition of Paper Target <p>Flashover is considered to have occurred when any two of the above criteria were met during the test.</p>	<ul style="list-style-type: none"> •Peak Heat Release = 257 kW •Max Floor Heat Flux = 2.3 kW/m² •Max Average Upper Layer Temperature = 809°F •No Flames exited doorway •The flashover indicators did not ignite. 	PASS
