VESCOM AMERICA FIRE TEST REPORT

NFPA 286 TESTING ON 20 OZ. TYPE II PVC WALLCOVERING WITH OSNABURG (POLYESTER/COTTON) BACKING WHEN INSTALLED TO AN INTERIOR WALL

G102951522SAT-010

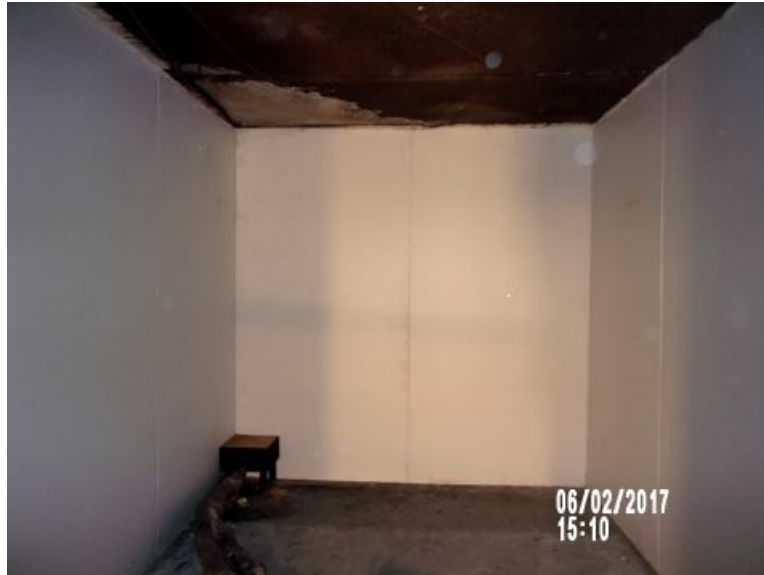
Photo No. 1
Pretest photo

The interior dimensions of the floor of the fire room, when the specimens are in place, measures 8 feet, by 12 feet. The finished ceiling is 8 feet \pm 0.5 inches above the floor. The four walls are at right angles defining the compartment. The compartment contains a 30 \pm 0.25 by 80 \pm 0.25 inch doorway in the center of one of the 8' by 8' walls. No other openings are present to allow ventilation.

The test specimen consisted of a 20 oz. Type II PVC wallcovering with Osnaburg (polyester/cotton) backing applied to 3/8" thick gypsum wall boards using ROMAN Pro 880 ultra-clear adhesive. The specimen was applied to the room in a vertical orientation. After application, the samples were allowed to cure in a conditioning room at 70°F \pm 2°F and 50% relative humidity \pm 5% for 14 days.

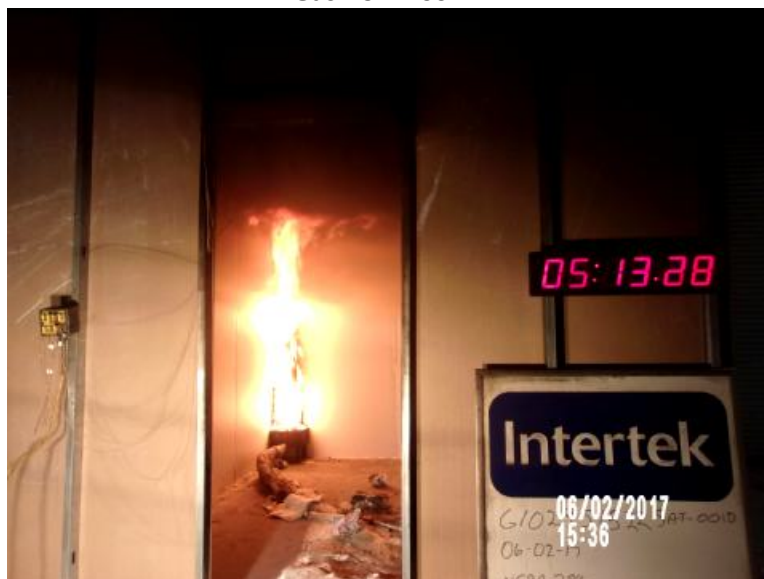
Photo No. 4
Gas flow 160kW

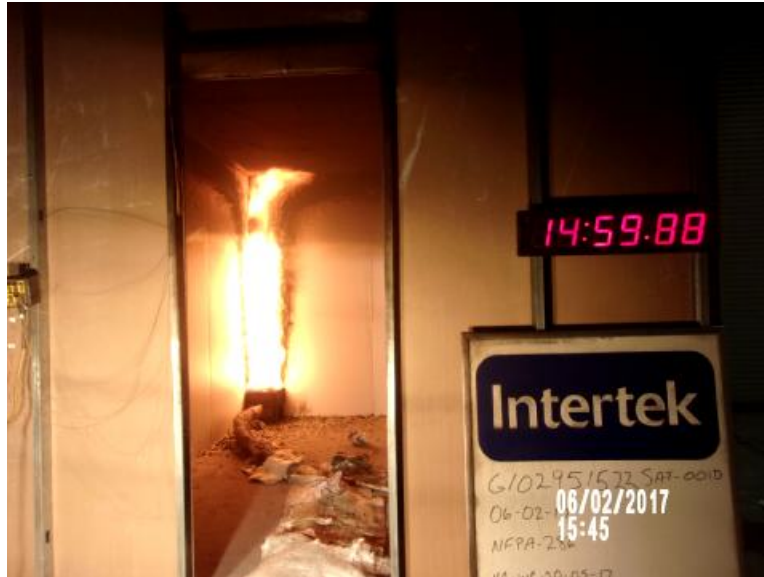
Photo No. 5
End of test

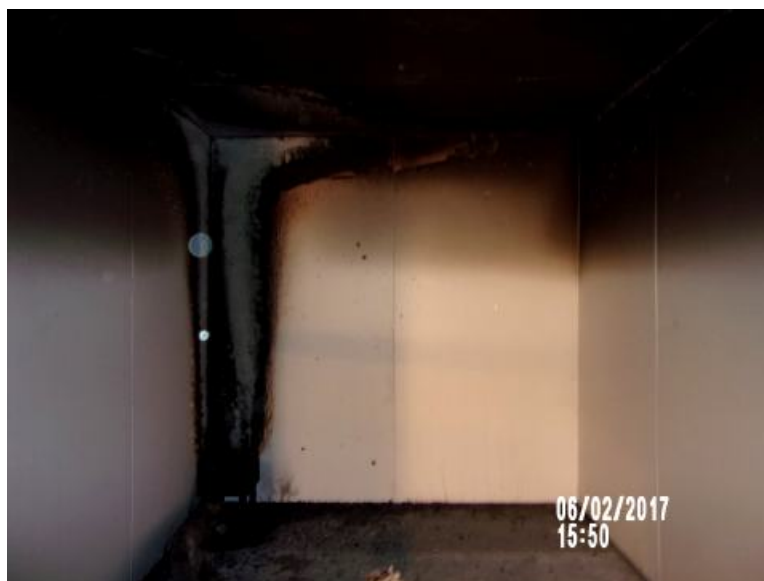
Photo No.6
Posttest photo

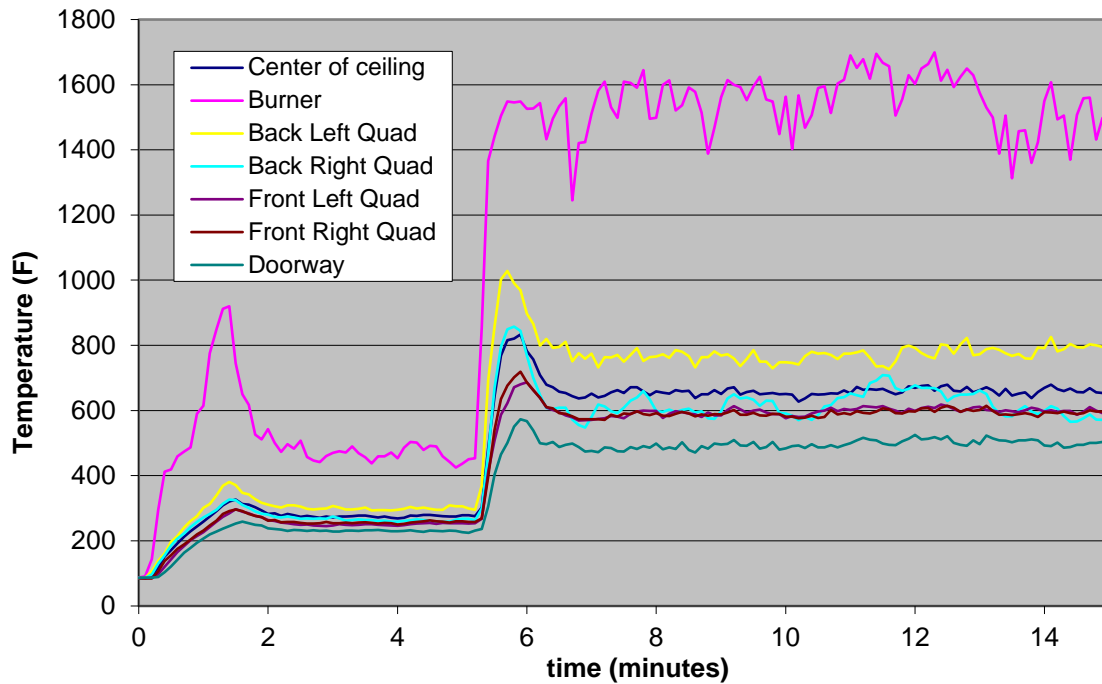
Graph No. 1
Thermocouple Data

2015 IBC SECTION 803.1.2.1 & NFPA 286 ANNEX C PERFORMANCE CRITERIA	TEST OBSERVATIONS	PASS/FAIL
During 40 kW exposure, flames should not spread to the ceiling.	Flames did not spread to the ceiling during the 40kW exposure.	PASS
During the 160 kW exposure, the interior finish should not spread to the outer extremity of the sample on any wall or ceiling	Flames propagation to the outer extremities did not occurred during the 160kW exposure.	PASS
<p>During the 160 kW exposure, the interior finish should not flashover as defined by NFPA 286.</p> <ul style="list-style-type: none"> •Peak Heat Release > 1 MW •Floor Heat Flux > 20 kW/m² •Average Upper Layer Temperature > 1,112°F •Flames exiting doorway •Auto ignition of Paper Target <p>Flashover is considered to have occurred when any two of the above criteria were met during the test.</p>	<ul style="list-style-type: none"> •Peak Heat Release = 257 kW •Max Floor Heat Flux = 2.3 kW/m² •Max Average Upper Layer Temperature = 809°F •No Flames exited doorway •The flashover indicators did not ignite. 	PASS

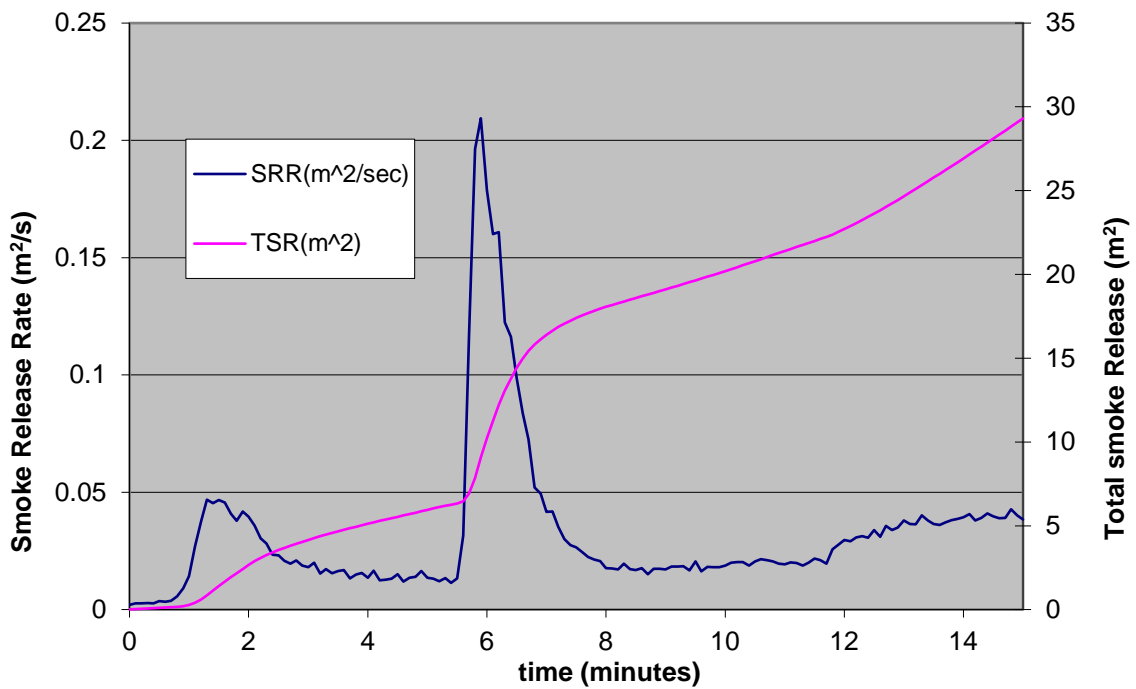
Graph No. 2

Smoke Release

The peak rate of heat release throughout the NFPA 286 test should not exceed 800 kW.	The peak heat release rate was 257 kW	PASS
The total smoke released throughout the NFPA 286 test should not exceed 1,000 m ² .	The total smoke released during the entirety of the test was 20.3 m ²	PASS

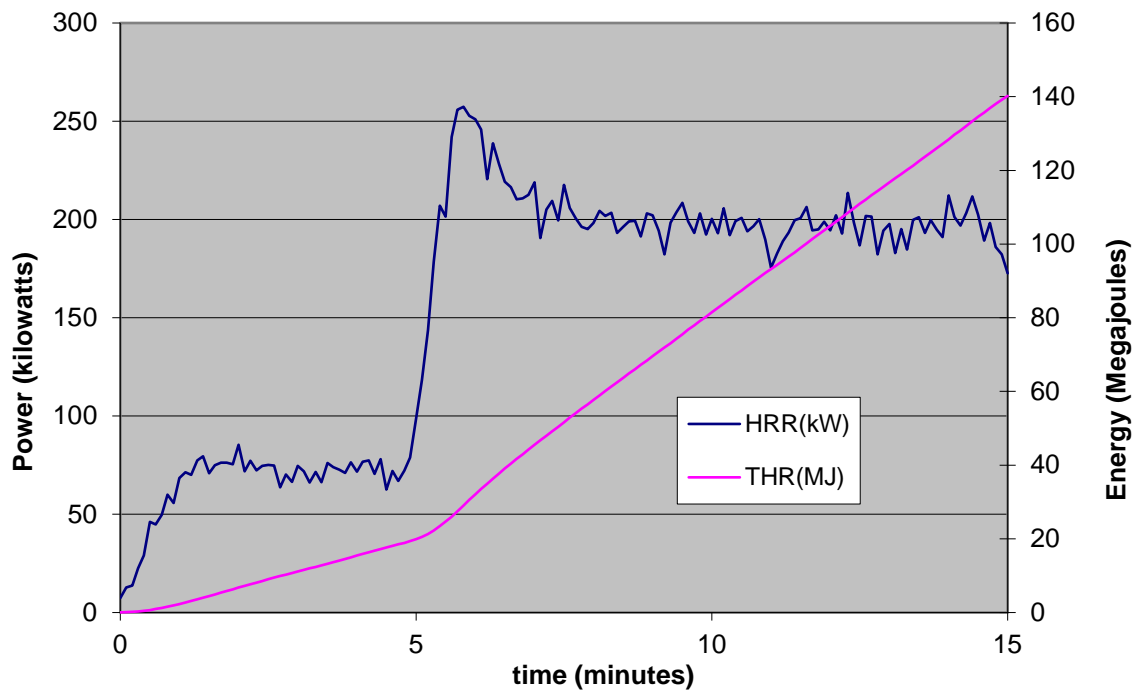
Graph No. 3

Heat Release

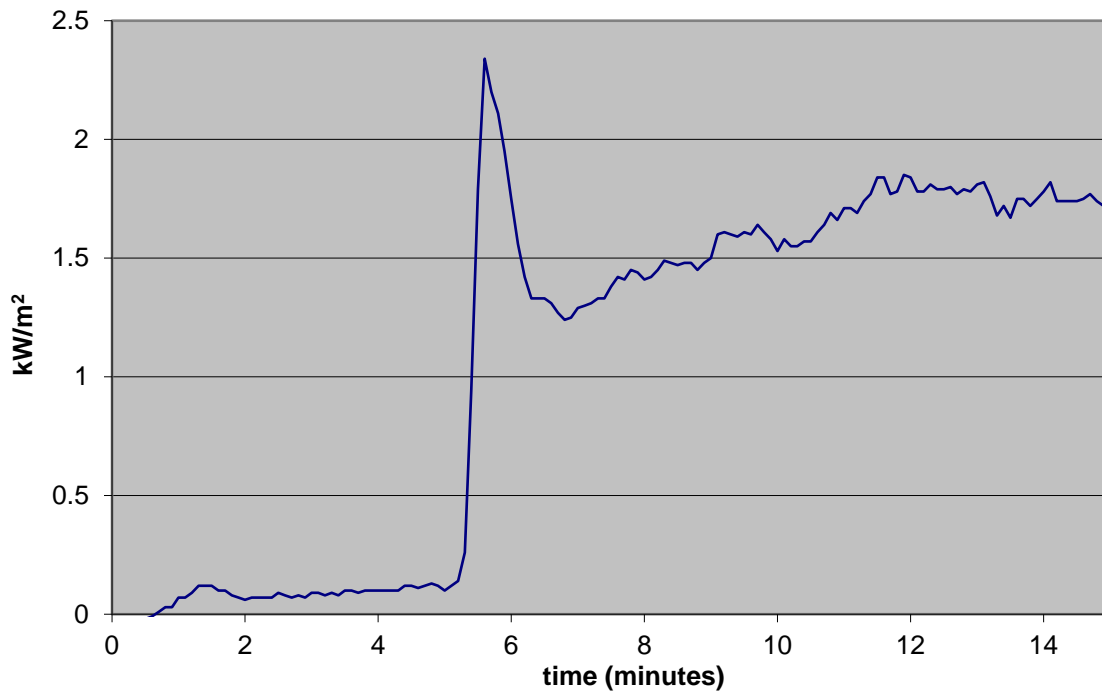
Graph No. 4

Radiant Heat
