VESCOM AMERICA FIRE TEST REPORT

NFPA 286 TESTING ON 20 OZ. TYPE II PVC WALLCOVERING WITH OSNABURG (POLYESTER/COTTON) BACKING WHEN INSTALLED TO AN INTERIOR WALL

G102951522SAT-010

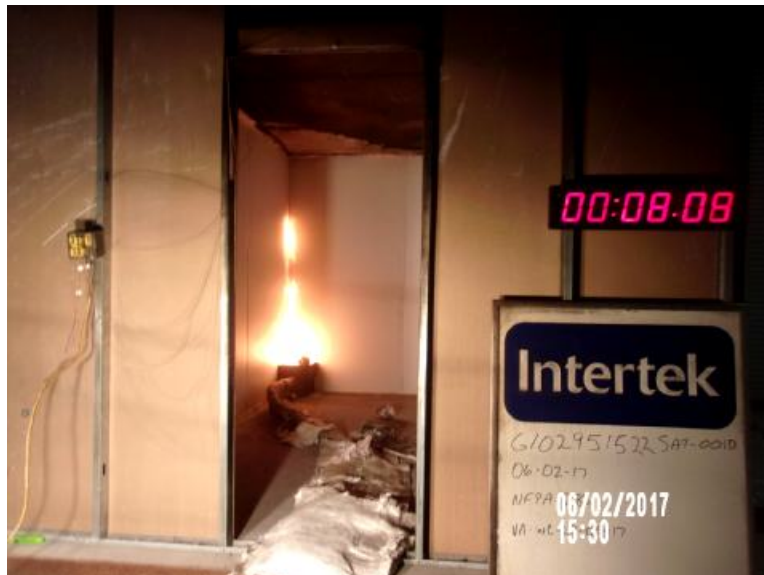
Photo No. 2
Start of test 40kW

TEST OBSERVATIONS	
Time (Min:Sec)	Observations
00:00	Ignition of the burner. Heat output set at 40kW
00:07	There was ignition of facer in burn corner
00:18	Flame tips 7ft vertically in corner above burner
00:54	Flaming drops
01:27	Flames recede back to burner
02:20	No change
05:00	Heat output was increased to 160kW
05:13	Horizontal flames at 5ft back and side wall
05:14	The smoke density increases
05:15	Flaming drops
06:11	Flame recede back to burner
06:13	Decrease in smoke
10:00	No change
12:00	No change
14:00	No change
15:00	The gas is turned off, testing complete

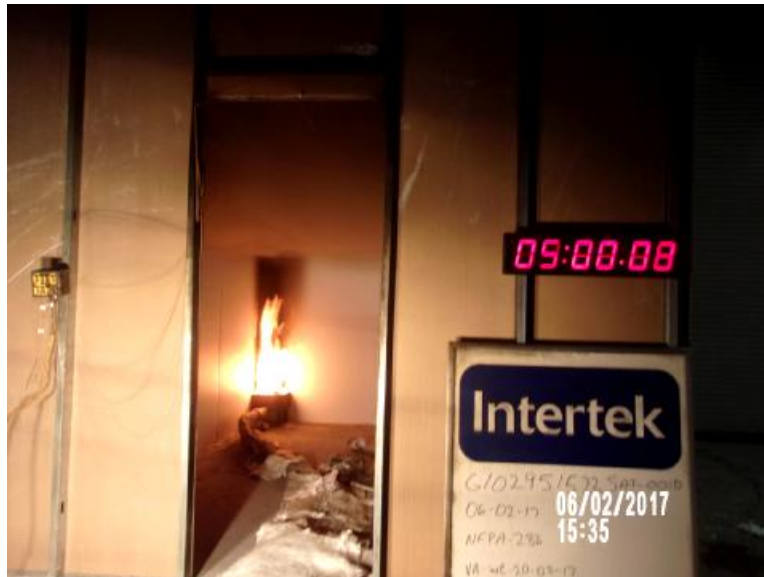
Photo No. 3
40kW

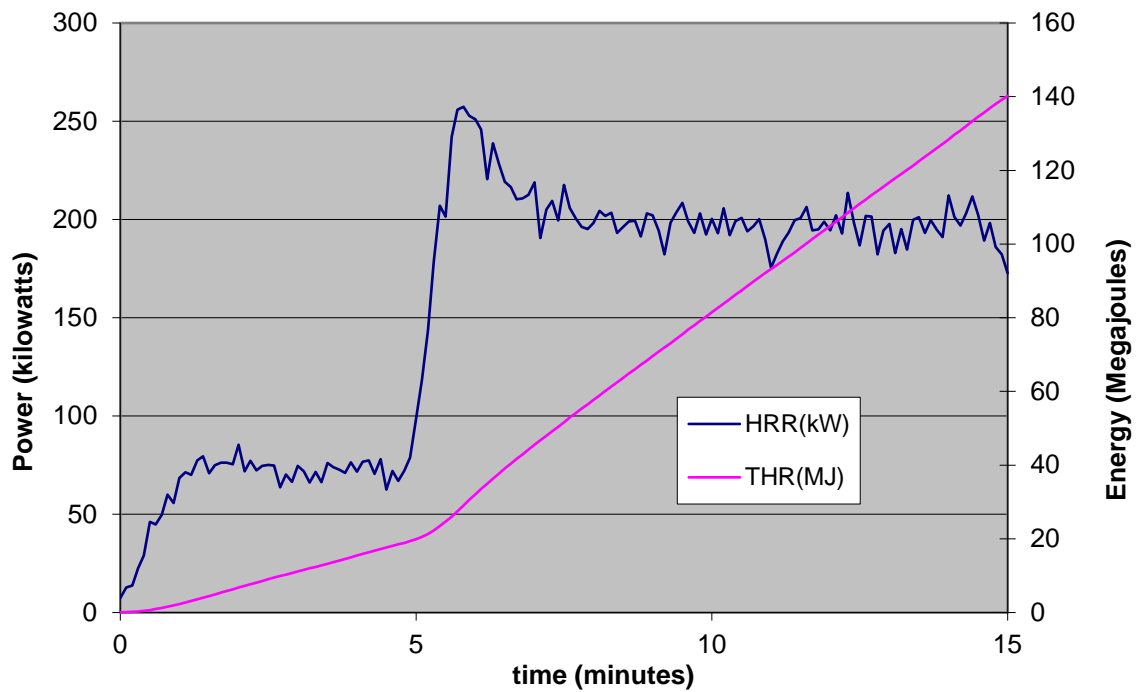
Graph No. 3

Heat Release

The peak rate of heat release throughout the NFPA 286 test should not exceed 800 kW.	The peak heat release rate was 257 kW	PASS
The total smoke released throughout the NFPA 286 test should not exceed 1,000 m ² .	The total smoke released during the entirety of the test was 20.3 m ²	PASS
