VESCOM AMERICA FIRE TEST REPORT

NFPA 286 TESTING ON 20 OZ. TYPE II PVC WALLCOVERING WITH OSNABURG (POLYESTER/COTTON) BACKING WHEN INSTALLED TO AN INTERIOR WALL

G102951522SAT-010

TEST REPORT FOR VESCOM AMERICA

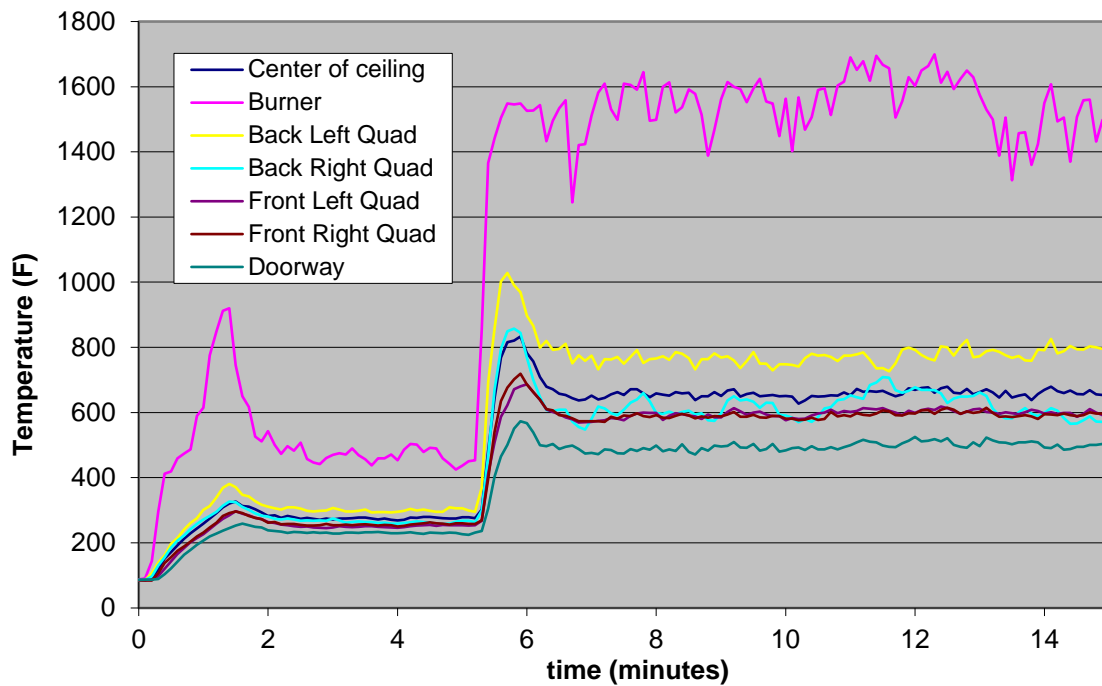
Graph No. 1
Thermocouple Data

2015 IBC SECTION 803.1.2.1 & NFPA 286 ANNEX C PERFORMANCE CRITERIA	TEST OBSERVATIONS	PASS/FAIL
During 40 kW exposure, flames should not spread to the ceiling.	Flames did not spread to the ceiling during the 40kW exposure.	PASS
During the 160 kW exposure, the interior finish should not spread to the outer extremity of the sample on any wall or ceiling	Flames propagation to the outer extremities did not occurred during the 160kW exposure.	PASS
<p>During the 160 kW exposure, the interior finish should not flashover as defined by NFPA 286.</p> <ul style="list-style-type: none"> •Peak Heat Release > 1 MW •Floor Heat Flux > 20 kW/m² •Average Upper Layer Temperature > 1,112°F •Flames exiting doorway •Auto ignition of Paper Target <p>Flashover is considered to have occurred when any two of the above criteria were met during the test.</p>	<ul style="list-style-type: none"> •Peak Heat Release = 257 kW •Max Floor Heat Flux = 2.3 kW/m² •Max Average Upper Layer Temperature = 809°F •No Flames exited doorway •The flashover indicators did not ignite. 	PASS
