VESCOM AMERICA FIRE TEST REPORT

NFPA 286 TESTING ON 20 OZ. TYPE II PVC WALLCOVERING WITH OSNABURG (POLYESTER/COTTON) BACKING WHEN INSTALLED TO AN INTERIOR WALL

G102951522SAT-010

TEST REPORT FOR VESCOM AMERICA

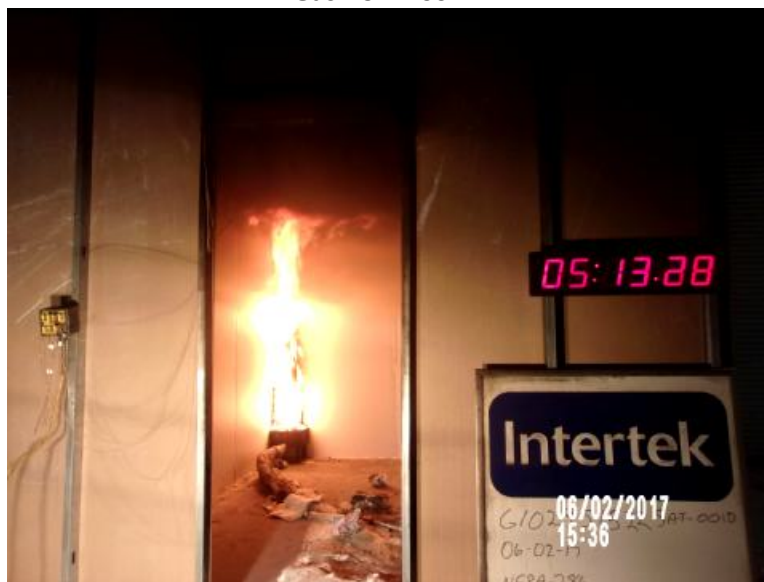
Photo No. 4
Gas flow 160kW

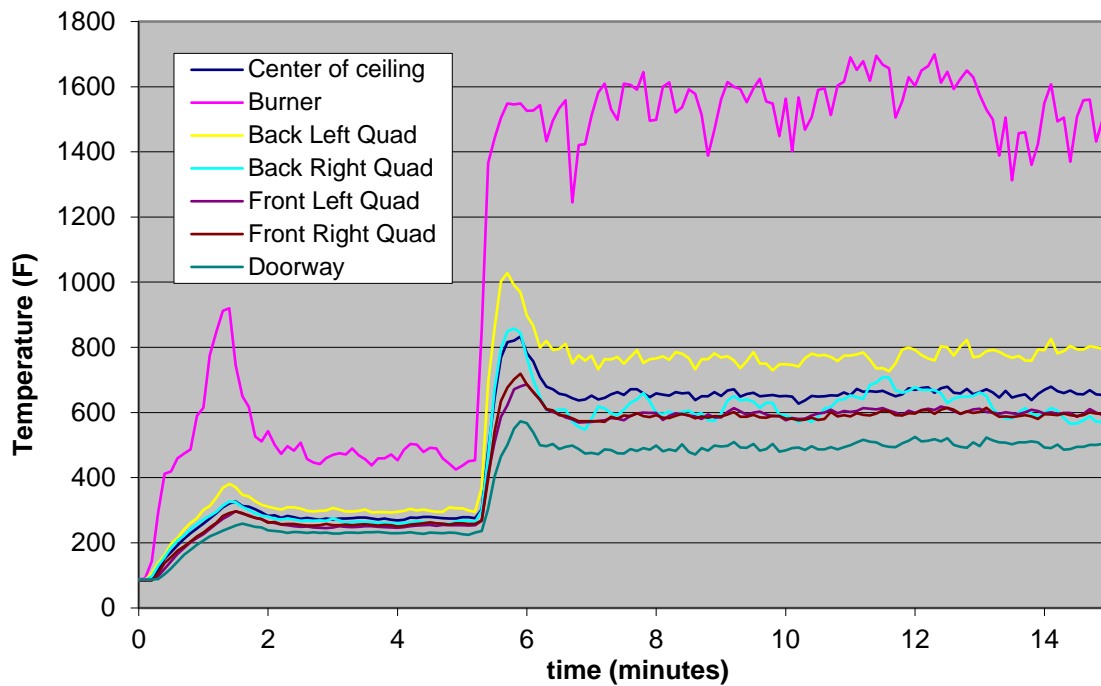
Graph No. 1
Thermocouple Data

2015 IBC SECTION 803.1.2.1 & NFPA 286 ANNEX C PERFORMANCE CRITERIA	TEST OBSERVATIONS	PASS/FAIL
During 40 kW exposure, flames should not spread to the ceiling.	Flames did not spread to the ceiling during the 40kW exposure.	PASS
During the 160 kW exposure, the interior finish should not spread to the outer extremity of the sample on any wall or ceiling	Flames propagation to the outer extremities did not occurred during the 160kW exposure.	PASS
<p>During the 160 kW exposure, the interior finish should not flashover as defined by NFPA 286.</p> <ul style="list-style-type: none"> •Peak Heat Release > 1 MW •Floor Heat Flux > 20 kW/m² •Average Upper Layer Temperature > 1,112°F •Flames exiting doorway •Auto ignition of Paper Target <p>Flashover is considered to have occurred when any two of the above criteria were met during the test.</p>	<ul style="list-style-type: none"> •Peak Heat Release = 257 kW •Max Floor Heat Flux = 2.3 kW/m² •Max Average Upper Layer Temperature = 809°F •No Flames exited doorway •The flashover indicators did not ignite. 	PASS
