VESCOM AMERICA FIRE TEST REPORT

NFPA 286 TESTING ON 20 OZ. TYPE II PVC WALLCOVERING WITH OSNABURG (POLYESTER/COTTON) BACKING WHEN INSTALLED TO AN INTERIOR WALL

G102951522SAT-010

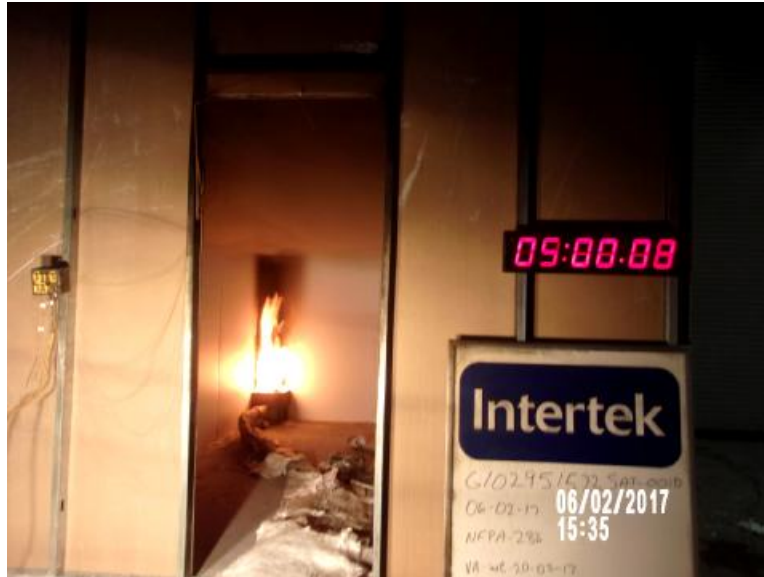
Photo No. 3
40kW

TEST OBSERVATIONS	
Time (Min:Sec)	Observations
00:00	Ignition of the burner. Heat output set at 40kW
00:07	There was ignition of facer in burn corner
00:18	Flame tips 7ft vertically in corner above burner
00:54	Flaming drops
01:27	Flames recede back to burner
02:20	No change
05:00	Heat output was increased to 160kW
05:13	Horizontal flames at 5ft back and side wall
05:14	The smoke density increases
05:15	Flaming drops
06:11	Flame recede back to burner
06:13	Decrease in smoke
10:00	No change
12:00	No change
14:00	No change
15:00	The gas is turned off, testing complete
