VESCOM AMERICA FIRE TEST REPORT

NFPA 286 TESTING ON 20 OZ. TYPE II PVC WALLCOVERING WITH OSNABURG (POLYESTER/COTTON) BACKING WHEN INSTALLED TO AN INTERIOR WALL

G102951522SAT-010

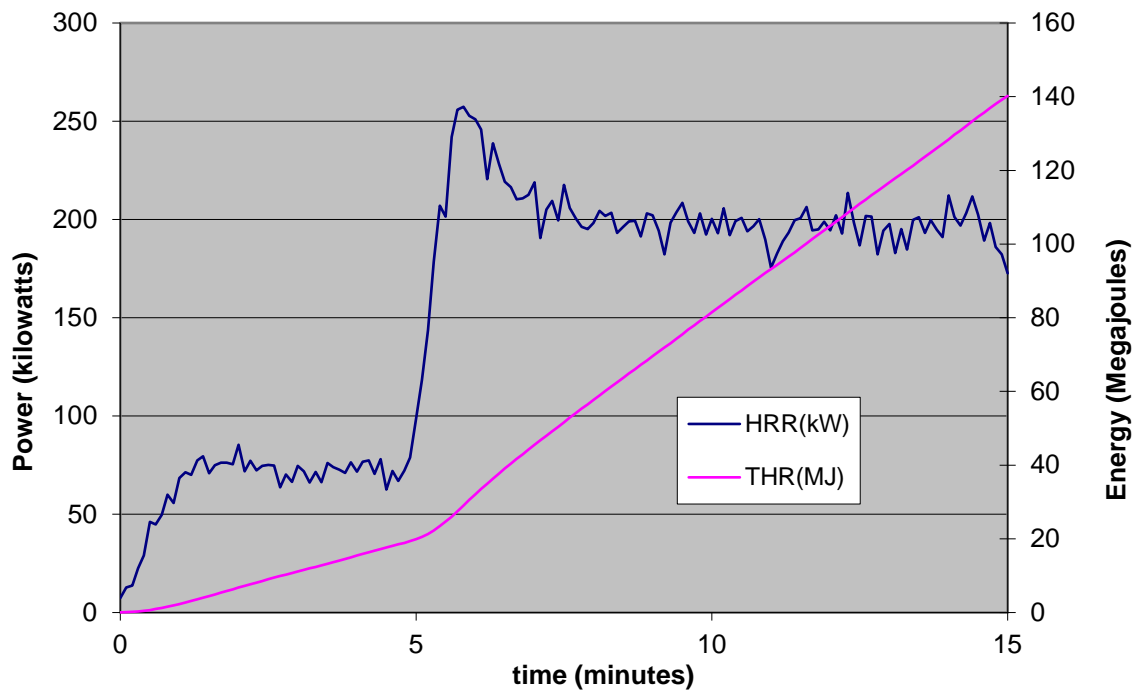
Graph No. 3

Heat Release

The peak rate of heat release throughout the NFPA 286 test should not exceed 800 kW.	The peak heat release rate was 257 kW	PASS
The total smoke released throughout the NFPA 286 test should not exceed 1,000 m ² .	The total smoke released during the entirety of the test was 20.3 m ²	PASS
