VESCOM AMERICA FIRE TEST REPORT

NFPA 286 TESTING ON 20 OZ. TYPE II PVC WALLCOVERING WITH OSNABURG (POLYESTER/COTTON) BACKING WHEN INSTALLED TO AN INTERIOR WALL

G102951522SAT-010

TEST REPORT FOR VESCOM AMERICA

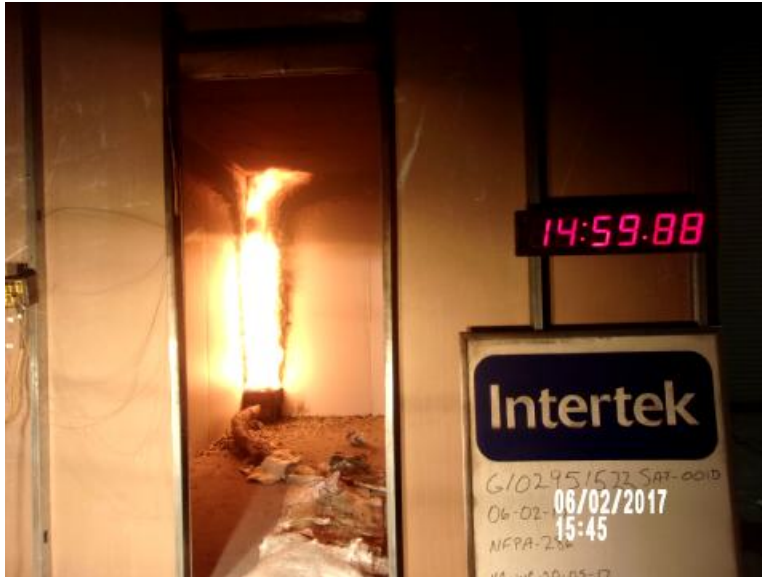
Photo No. 5
End of test

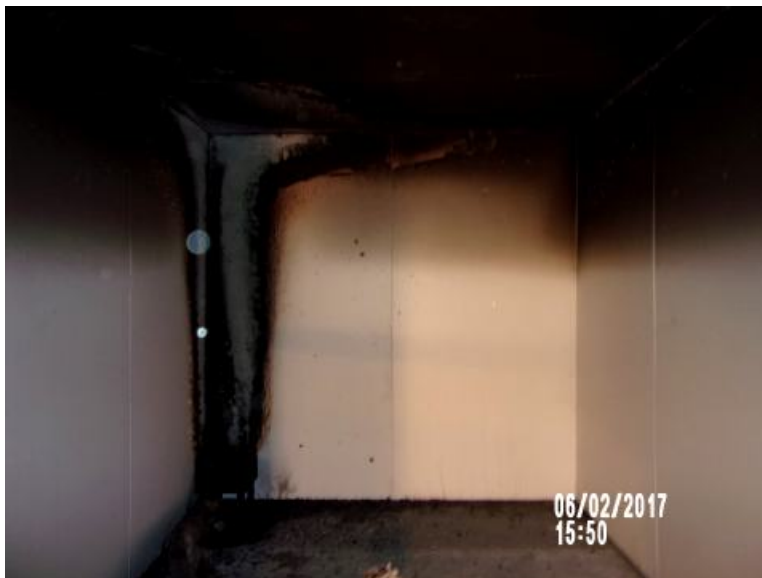
Photo No.6
Posttest photo
