Test Specimen:	Specimen:	Colour:	Client reference number:
	A.	Grey	Leone Plus 7054.15

Examination:	Test number:	Test Name:
	1.	Furniture – Assessment of surface resistance to cold liquids.
	2.	Photos – before cleaning and after cleaning.

Test : 1. Furniture – Assessment of surface resistance to cold liquids.
Norm : NEN EN 12720
Liquids : Medicarine tablets (2 tablets in 300 ml demineralized water)
Drying time : 1 hour at 23°C in the Binder Refrigerated Incubator Model: KT 53 (E6).
Numerical rating : Descriptive numerical rating code:

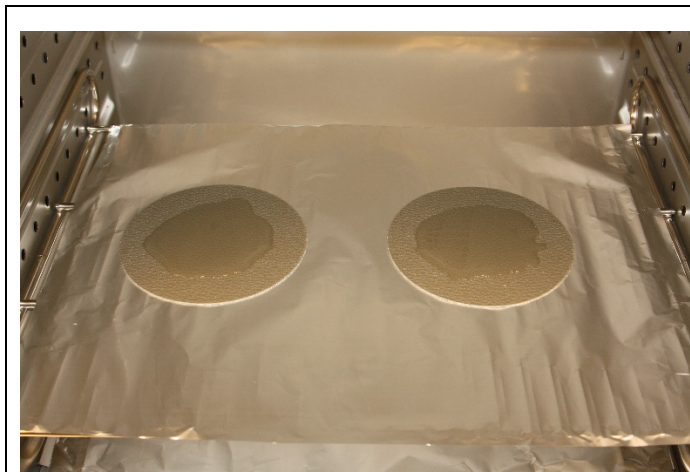
Specimen A medicarine tablets – before the test.

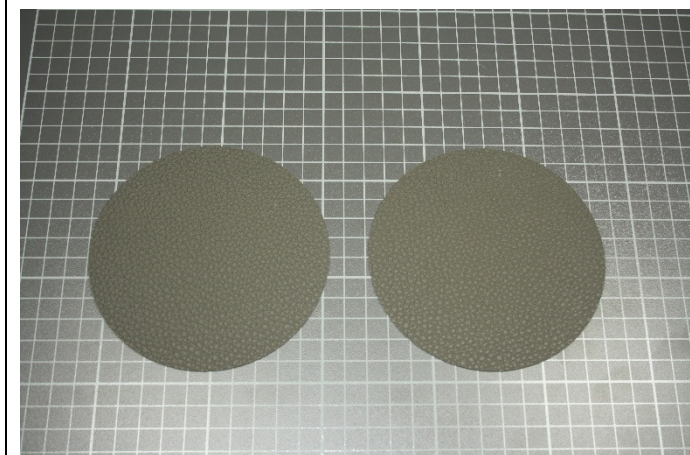
Specimen A medicarine tablets – after the test.

Results test 1 specimen:	A.
Medicarine tablets:	
1e	4/5
2e	4/5
