# VESCOM AMERICA FIRE TEST REPORT

NFPA 286 TESTING ON 20 OZ. TYPE II PVC WALLCOVERING WITH OSNABURG (POLYESTER/COTTON) BACKING WHEN INSTALLED TO AN INTERIOR WALL

G102951522SAT-010

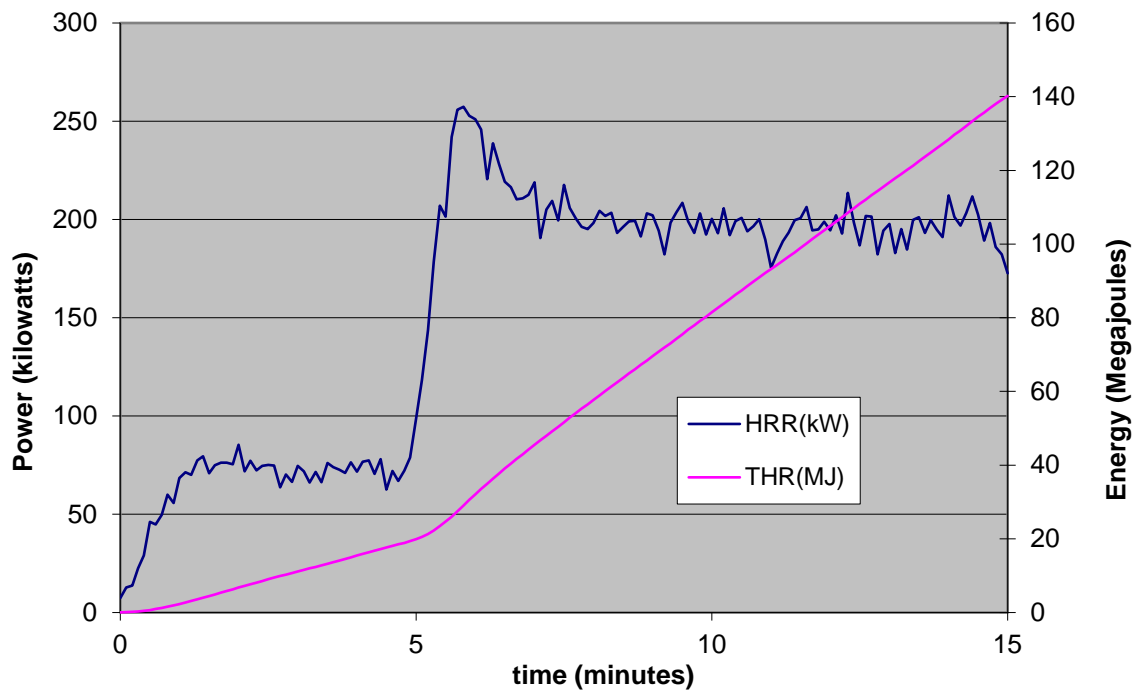
Graph No. 3

### Heat Release

The peak rate of heat release throughout the NFPA 286 test should not exceed 800 kW.	The peak heat release rate was 257 kW	<b>PASS</b>
The total smoke released throughout the NFPA 286 test should not exceed 1,000 m <sup>2</sup> .	The total smoke released during the entirety of the test was 20.3 m <sup>2</sup>	<b>PASS</b>
