# VESCOM AMERICA FIRE TEST REPORT

NFPA 286 TESTING ON 20 OZ. TYPE II PVC WALLCOVERING WITH OSNABURG (POLYESTER/COTTON) BACKING WHEN INSTALLED TO AN INTERIOR WALL

G102951522SAT-010

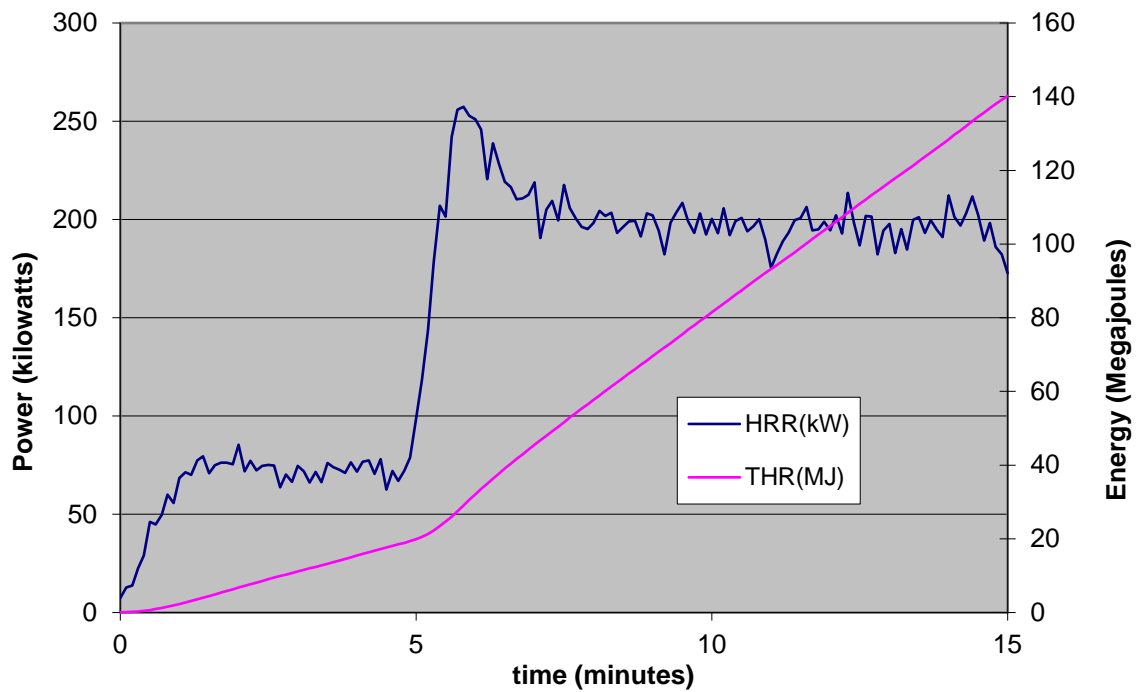
Graph No. 3

### Heat Release

The peak rate of heat release throughout the NFPA 286 test should not exceed 800 kW.	The peak heat release rate was 257 kW	<b>PASS</b>
The total smoke released throughout the NFPA 286 test should not exceed 1,000 m <sup>2</sup> .	The total smoke released during the entirety of the test was 20.3 m <sup>2</sup>	<b>PASS</b>

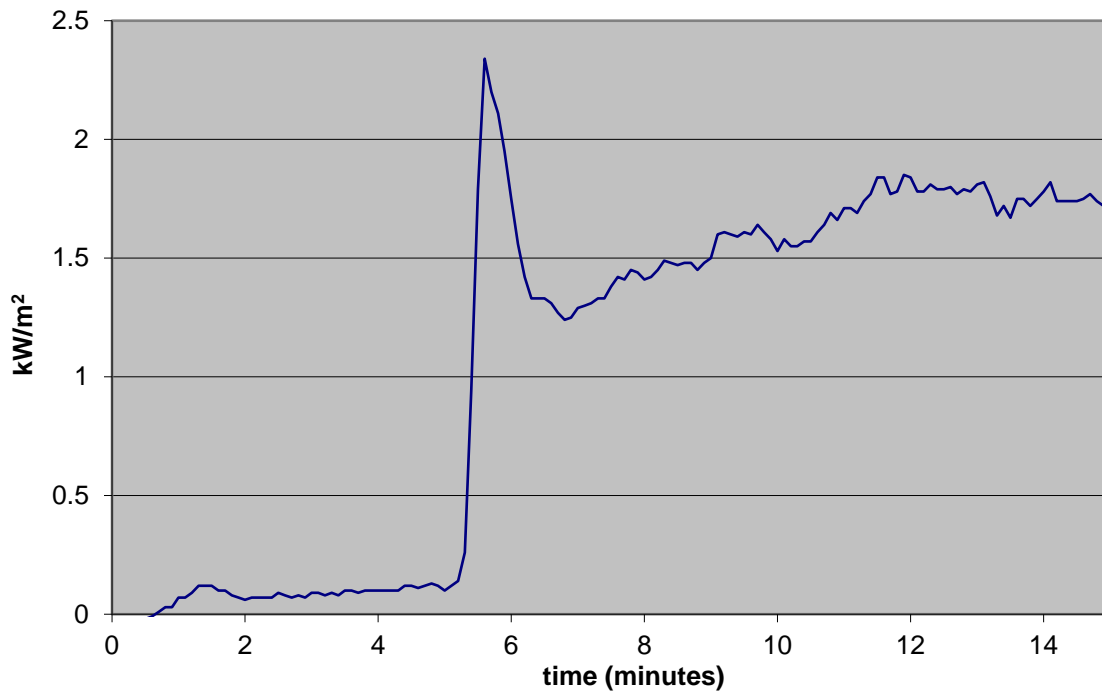
Graph No. 4

### Radiant Heat
