VESCOM AMERICA FIRE TEST REPORT

NFPA 286 TESTING ON 20 OZ. TYPE II PVC WALLCOVERING WITH HEAVY COTTON BACKING WHEN INSTALLED TO AN INTERIOR WALL .

G102951522SAT-012

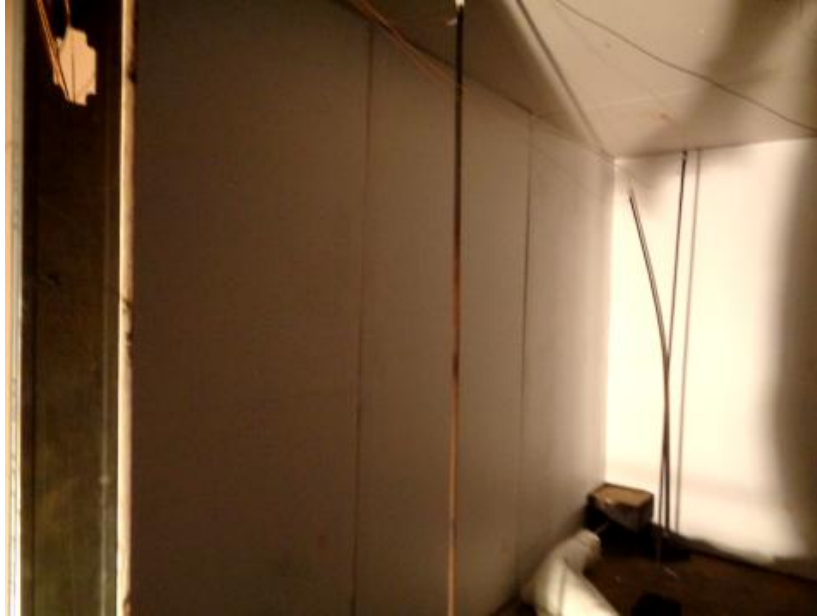
Photo No. 1
Pre test photo

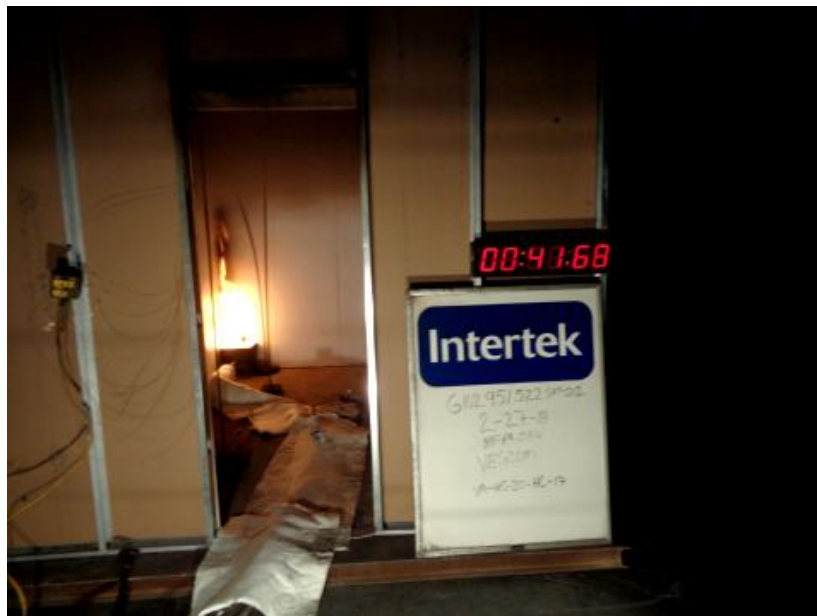
Photo No. 2
Start of test 40kW

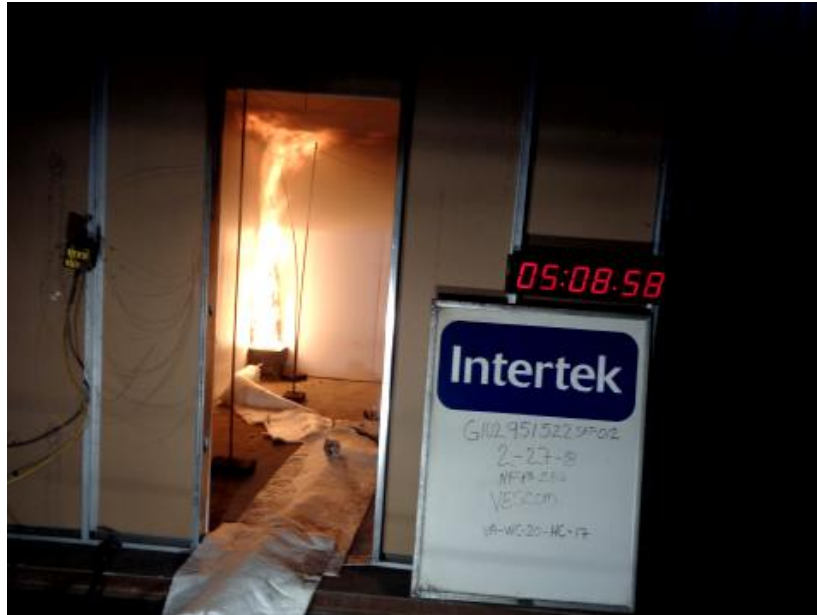
Photo No. 3
Increased Gas flow 160kW

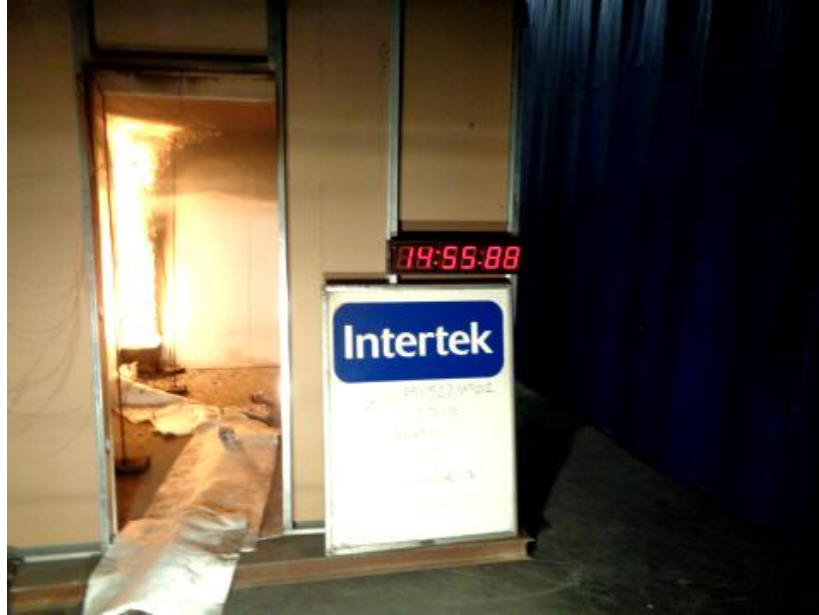
Photo No. 5
End of test

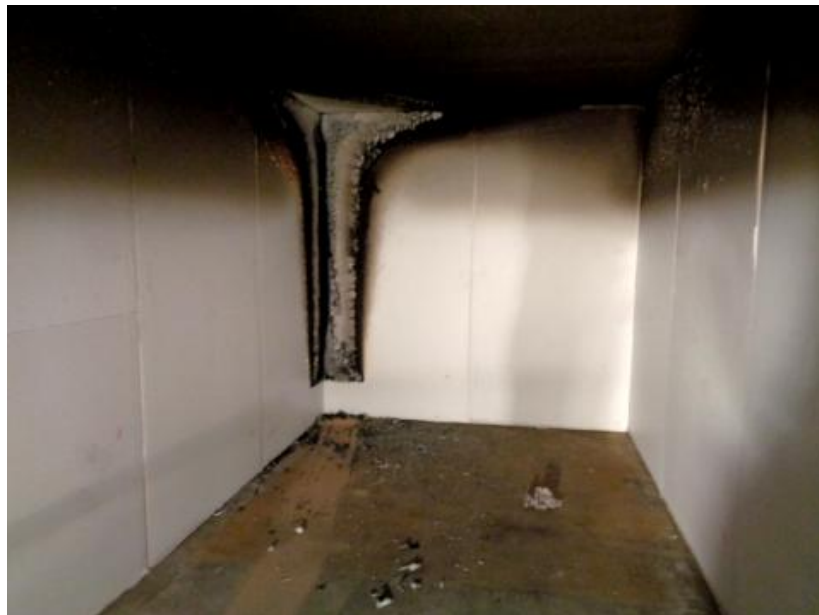
Photo No.6
Post Test photo

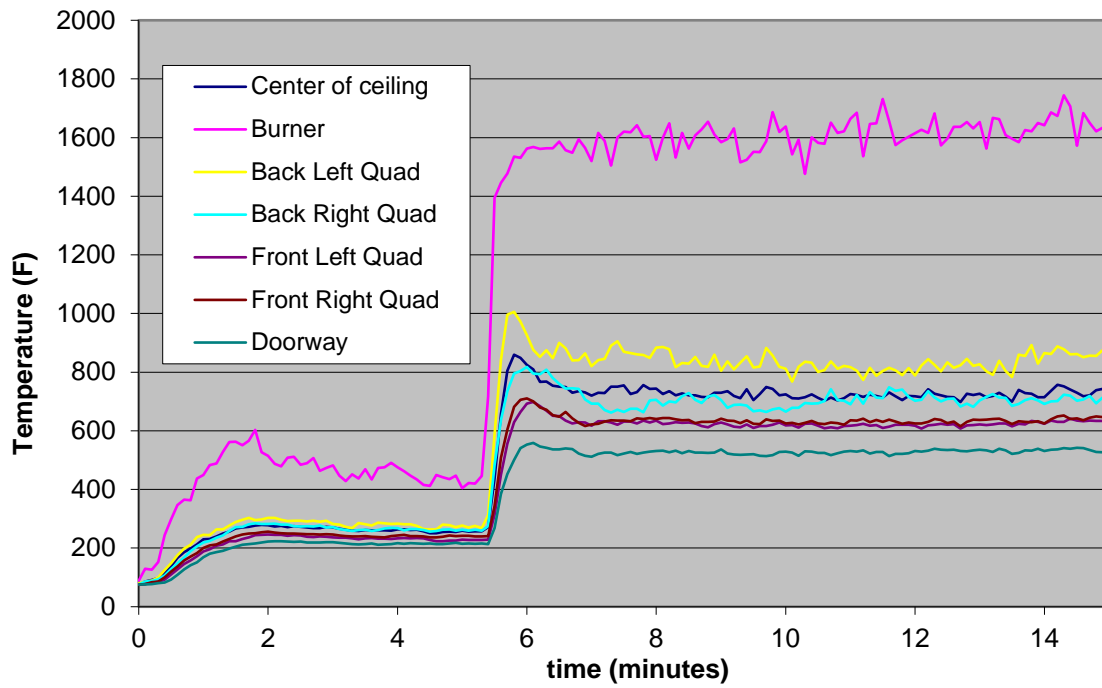
Graph No. 1

Thermocouple Data
