# VESCOM AMERICA FIRE TEST REPORT

NFPA 286 TESTING ON 20 OZ. TYPE II PVC WALLCOVERING WITH OSNABURG (POLYESTER/COTTON) BACKING WHEN INSTALLED TO AN INTERIOR WALL

G102951522SAT-010

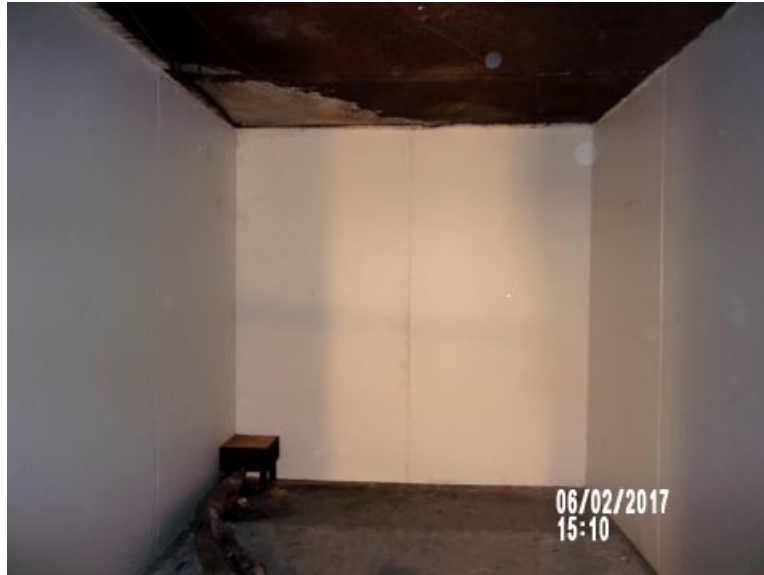
**Photo No. 1**  
**Pretest photo**

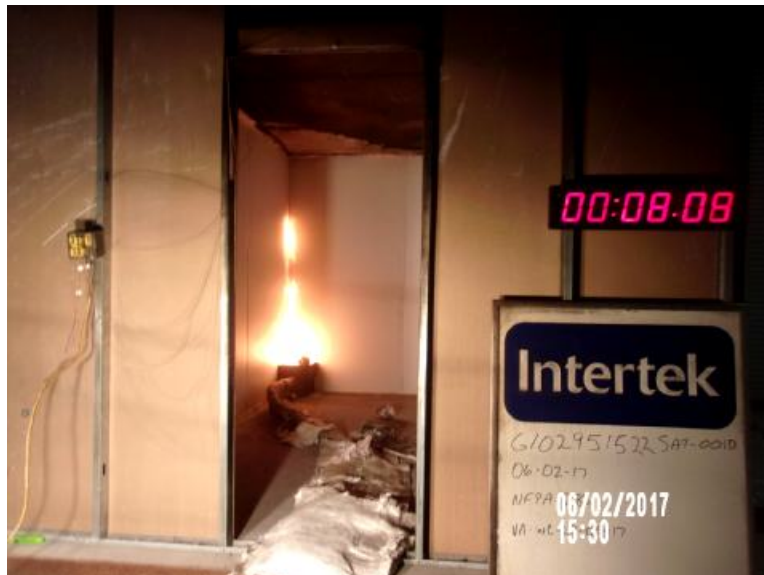
**Photo No. 2**  
**Start of test 40kW**

TEST OBSERVATIONS	
Time (Min:Sec)	Observations
00:00	Ignition of the burner. Heat output set at 40kW
00:07	There was ignition of facer in burn corner
00:18	Flame tips 7ft vertically in corner above burner
00:54	Flaming drops
01:27	Flames recede back to burner
02:20	No change
05:00	Heat output was increased to 160kW
05:13	Horizontal flames at 5ft back and side wall
05:14	The smoke density increases
05:15	Flaming drops
06:11	Flame recede back to burner
06:13	Decrease in smoke
10:00	No change
12:00	No change
14:00	No change
15:00	The gas is turned off, testing complete

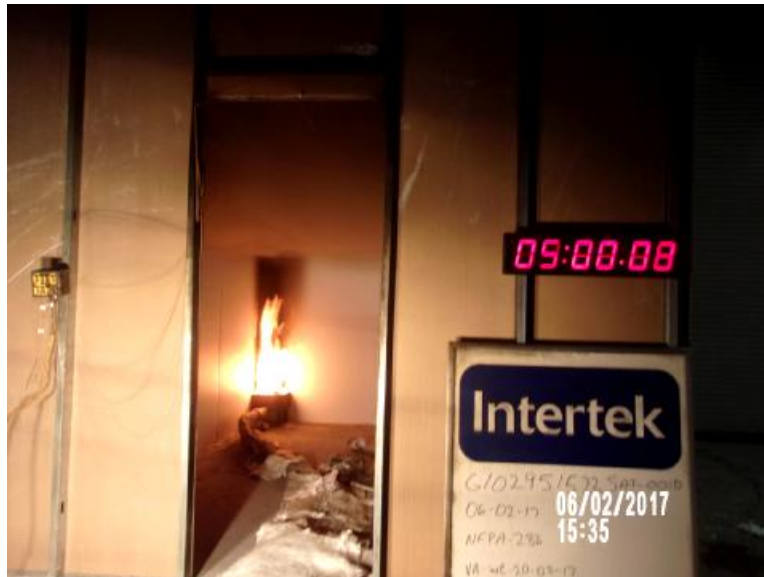
**Photo No. 3**  
**40kW**

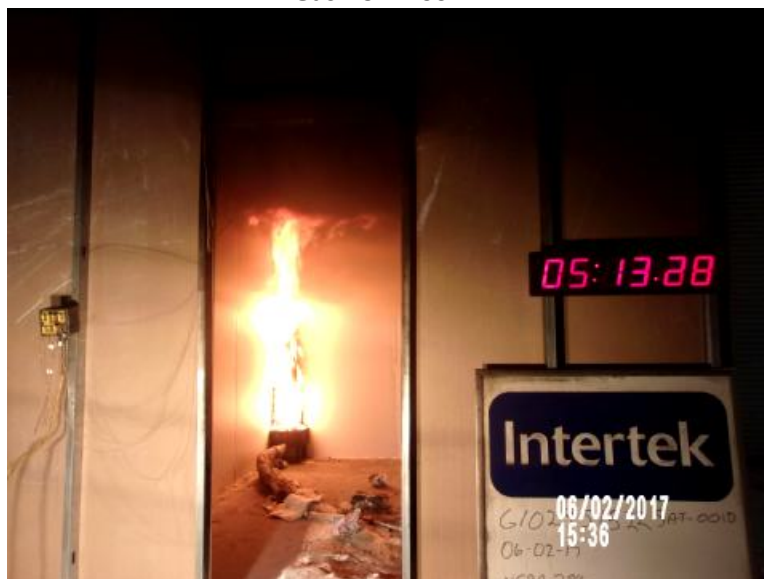
**Photo No. 4**  
**Gas flow 160kW**

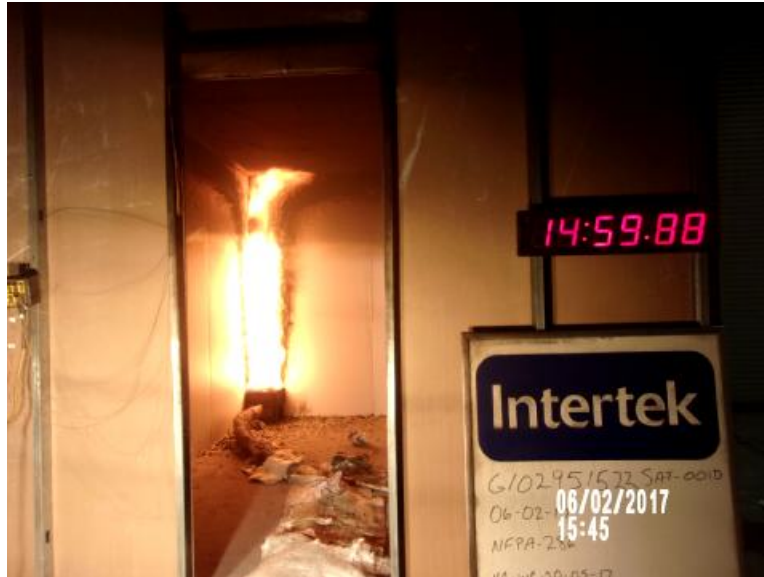
**Photo No. 5**  
**End of test**

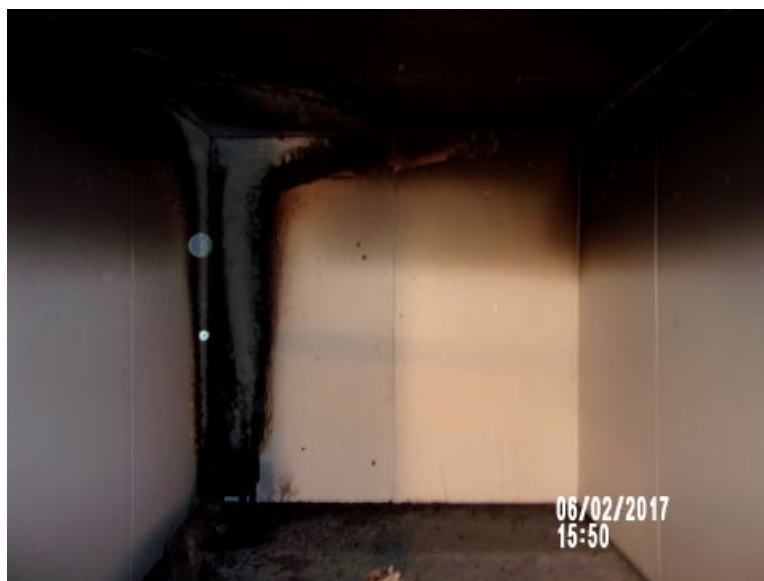
**Photo No.6**  
**Posttest photo**

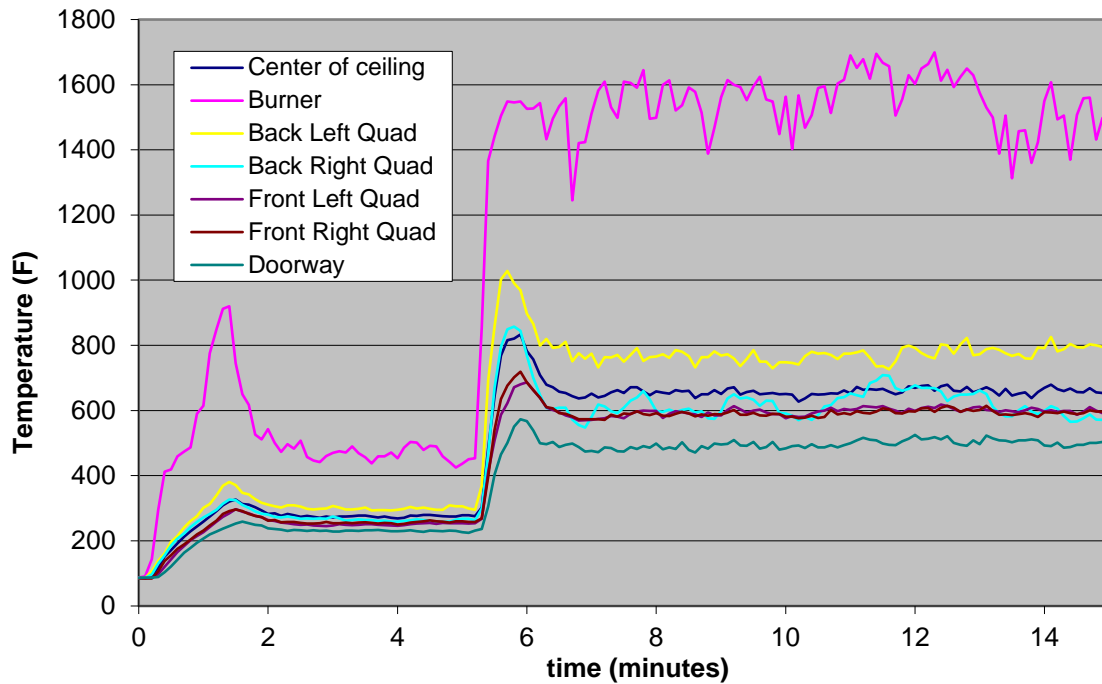
**Graph No. 1**  
**Thermocouple Data**
