# VESCOM AMERICA FIRE TEST REPORT

NFPA 286 TESTING ON 20 OZ. TYPE II PVC WALLCOVERING WITH OSNABURG (POLYESTER/COTTON) BACKING WHEN INSTALLED TO AN INTERIOR WALL

G102951522SAT-010

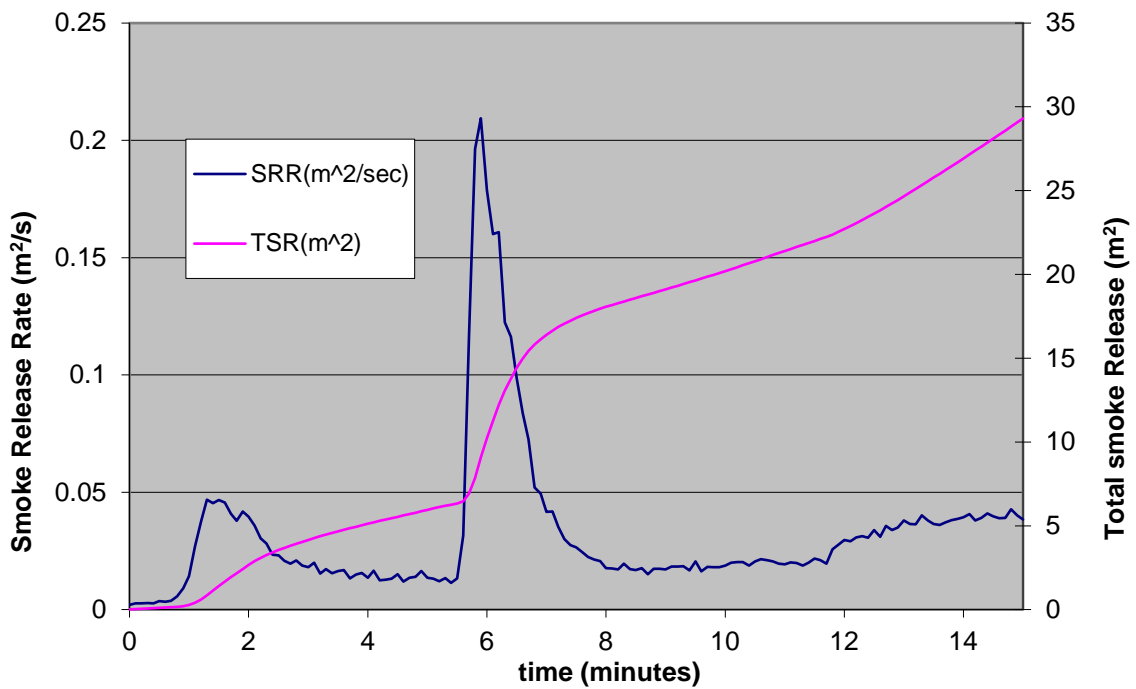
Graph No. 2

### Smoke Release

The peak rate of heat release throughout the NFPA 286 test should not exceed 800 kW.	The peak heat release rate was 257 kW	<b>PASS</b>
The total smoke released throughout the NFPA 286 test should not exceed 1,000 m <sup>2</sup> .	The total smoke released during the entirety of the test was 20.3 m <sup>2</sup>	<b>PASS</b>

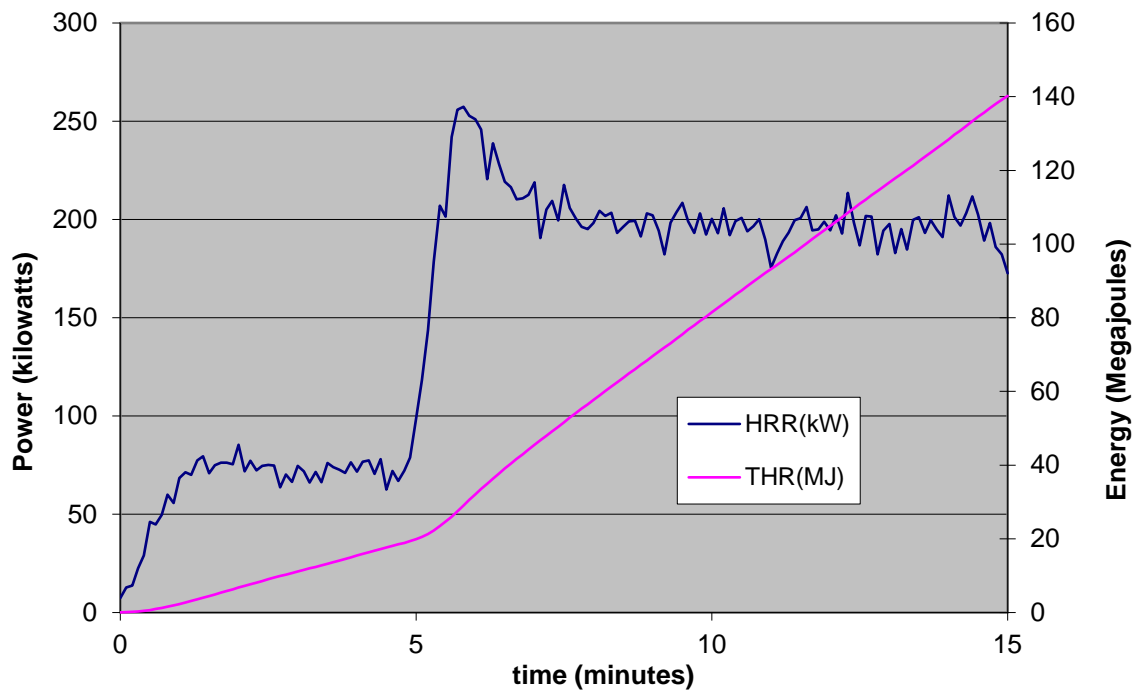
Graph No. 3

### Heat Release

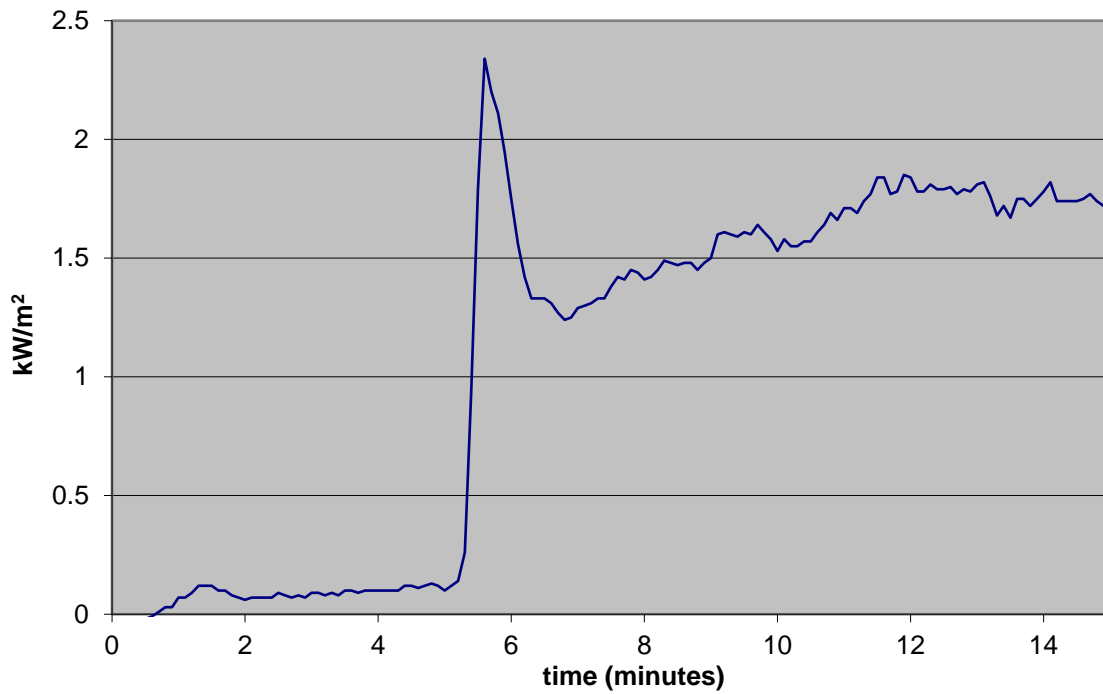
Graph No. 4

### Radiant Heat
